## Product Overview

# MAP SENSORS

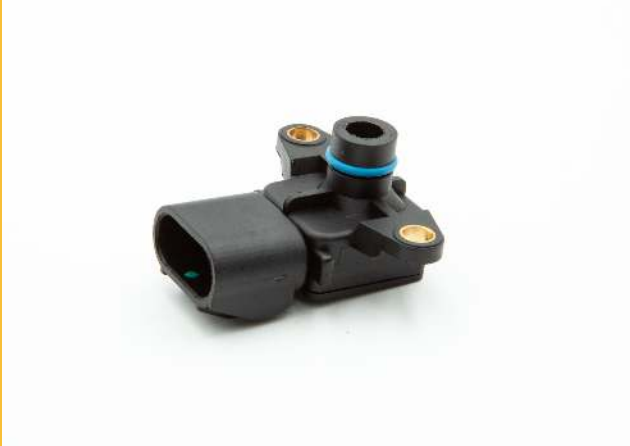
- Holstein Parts Manifold Absolute Pressure Sensors (MAP sensors) offer superior coverage for Import / Domestic applications
- Holstein Parts uses only the highest quality materials, manufactured to exacting standards to provide long term function and performance
- Sealed Anti-Static Protective Packaging ensures that electrical components are not damaged during shipping

The Manifold Absolute Pressure Sensor (MAP sensor) is one of the sensors used in a vehicle's electronic control system (ECU). Engines that use a MAP sensor are typically fuel injected. The MAP Sensor provides instantaneous manifold pressure information to the engine's computer (ECU). The data is used to calculate air density and determine the engine's air mass flow rate, which determines the required fuel metering for optimum combustion and influences the advance or retard of the ignition timing. A faulty MAP Sensor can cause a vehicle to run rich or lean, which will affect the vehicle's ignition timing and cause the engine not to run smoothly.

The sensor provides instant manifold pressure information to the engine's electronic control unit. The data is used to calculate air density and determine the engine's air mass flow rate, which in turn determines the required fuel delivery for perfect combustion.

The MAP sensor is typically located on the intake manifold, either next to or on the throttle body itself. (On a forced-induction engine, the MAP sensor can be found on the intake tract before the turbo.

MAP sensors fail by getting clogged, contaminated, or damaged. Sometimes, engine heat "overcooks" the MAP sensor's electronics or cracks vacuum lines.
